REPORT BMS93

Accumulation of Moisture in
Walls of Frame Construction
During Winter Exposure

NATIONAL
BUREAU OF STANDARDS

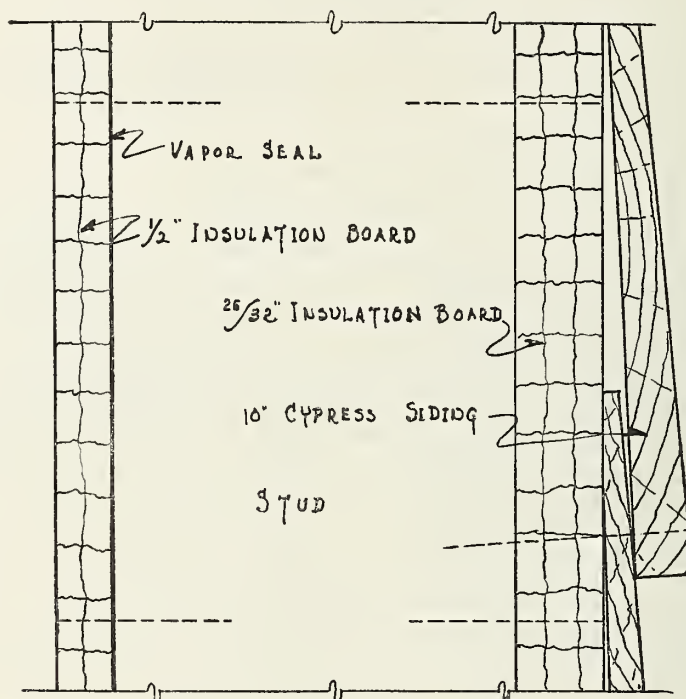
FIGURE 1.—Section of test panel *A*.

Section *A*, shown in figure 1, consisted of 2-by 4-inch studding with $\frac{1}{2}$ -inch insulation wallboard nailed to the inside and $2\frac{5}{32}$ -inch fiber sheathing board nailed to the outside. The

outside of the sheathing was covered with 10-inch cypress siding lapped 3 inches. The siding was painted on the outside with one coat of primer and two coats of outside white paint. A vapor barrier consisting of a 2-ounce copper foil bonded with asphalt to a backing of kraft paper was placed immediately under the wallboard on the inside of the studding, with all joints lapped 4 inches.

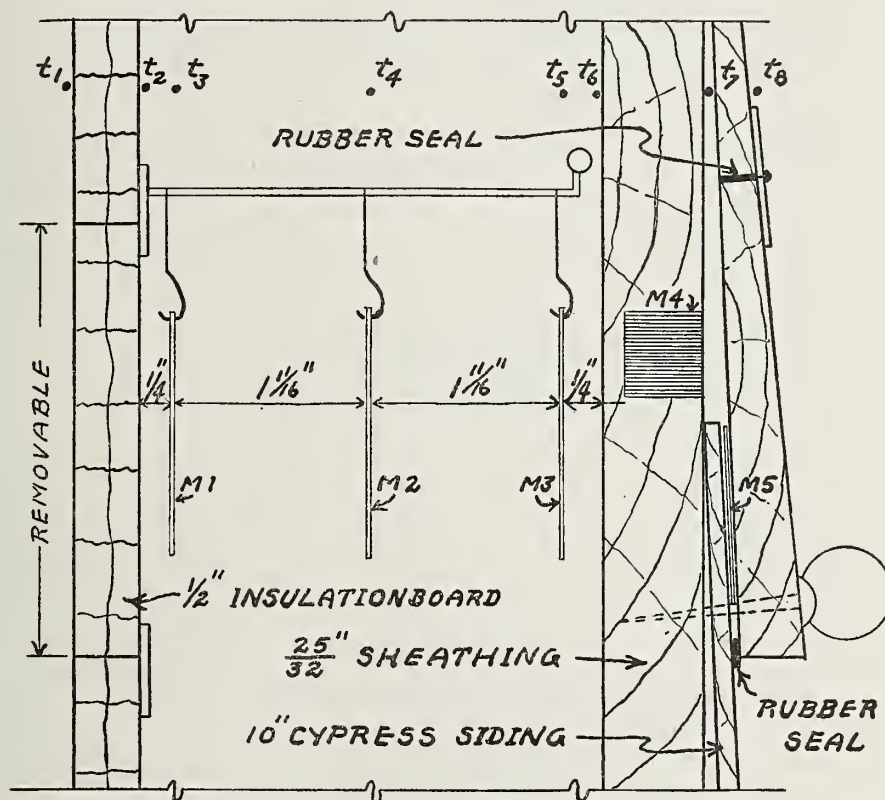
FIGURE 2.—Details of construction of test walls, showing locations where moisture and temperature determinations were made.

wall at approximately breathing level and at 10 inches above the floor level. Temperatures were measured with the use of Chromel-Alumel thermocouples and a suitable potentiometer. Moisture data were obtained by checking the weights of specimens of photographic blotting paper of known relative-humidity-moisture-content relationship. The location of the

thermocouples (t) and of the moisture samples (m) with respect to the cross section of the walls, and the method of construction to permit access to the moisture samples are shown in figure 2. The arrangement permitted the removal of the moisture specimens for weighing with a minimum of disturbance and, of course, temperature determinations were made without disturbing the wall. At the end of the 14-day period, the sections were opened and wet areas noted by inspection.

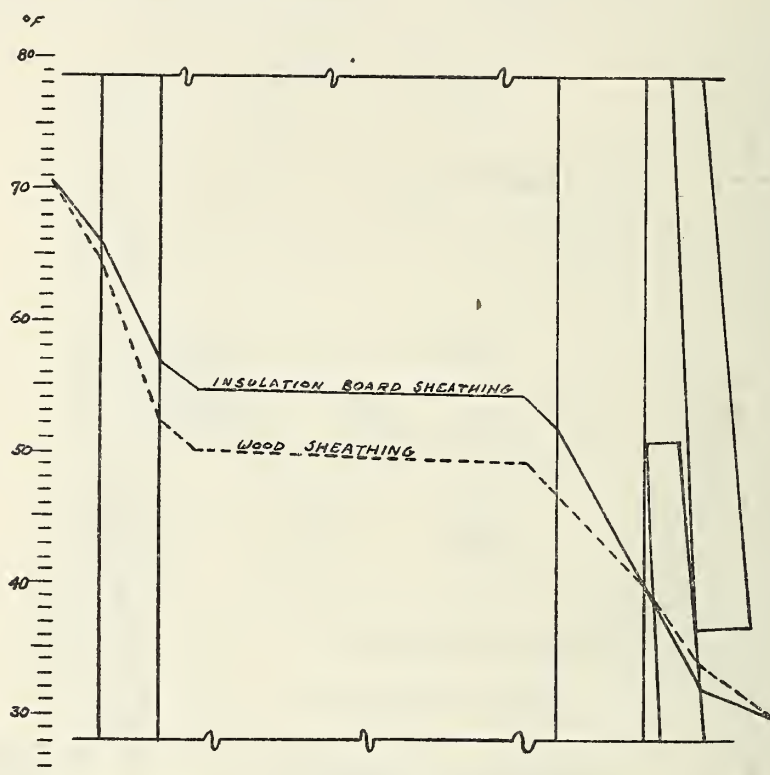
FIGURE 3.—Comparative temperature distributions through walls constructed with insulation sheathing and with wood sheathing.

Comparative average temperature distributions through the wall sections containing fiber sheathing boards and those containing wood sheathing are shown in figure 3. The spread between the two distributions across the air space between the studding represents

the beneficial effects of the higher insulation value of the fiber sheathing over that of the wood sheathing.
